FIRST FLIGHT OF THE ECARAVAN – MAGNIX AND AEROTEC’S ALL-ELECTRIC CESSNA 208B TECHNOLOGY DEMONSTRATOR

In May of 2020, magniX and AeroTEC successfully flew the first all-electric Cessna 208B Caravan, referred to as the eCaravan. At the time, it was the largest commercial all-electric aircraft to fly, a milestone achievement in the flight testing of electric powered aircraft. The test team was a combination of magniX subject matter experts, with extensive flight test experience, and AeroTEC Flight Test Engineering, Instrumentation, Test Pilot, Maintenance and Operational staff. The program brought together several outsourced components and required strict configuration control to ensure the success and safety of the flight test program. Potential hazards were documented and discussed, and a thorough risk mitigation plan was put into place to address the complexity of the system, integration and new technology employed. Critical component failure during crucial phases of flight were taken into consideration and mitigation strategies were not only extensively practiced but actually employed during the flight. This paper will examine the methods and processes used to modify the platform

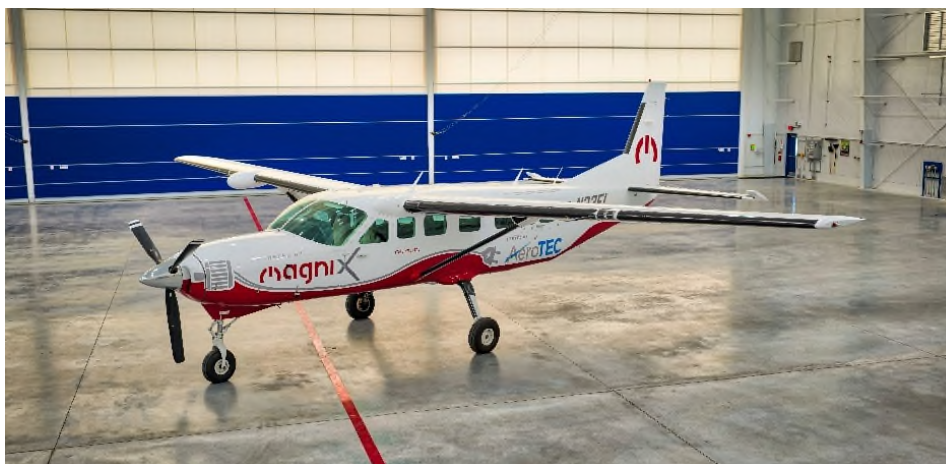
Figure 1 – The eCaravan

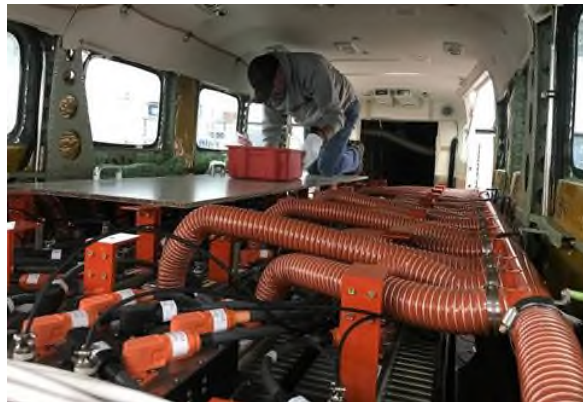
The design of the battery system was intended to provide the highest level of safety level through its internal module design, independent of the integration into the aircraft. The majority of the integration efforts were focused on the mechanical fixtures required to ensure sufficient structural capacity due to the large mass. Optimization of the module configuration was performed to provide enough spacing between modules to aid with passive cooling. Ducting was installed to provide an escape path for gases generated if a thermal runaway event happened. Thermal and system monitoring were some of the principal drivers in the design with each battery cell housed in individual casings that provided a passive means to contain thermal heating and to isolate individual cells from cascading thermal runaway events. Any off-gassing through ports on the top of each cell could be collected and ported overboard through a fan and ducting system designed specifically to handle such occurrences. A false floor was placed over the batteries and ducting to provide an additional egress path for the test pilot and safety for personnel as shown in Figure 10:

Figure 10 – Battery Cluster Assembly, Ducting, & False Floor

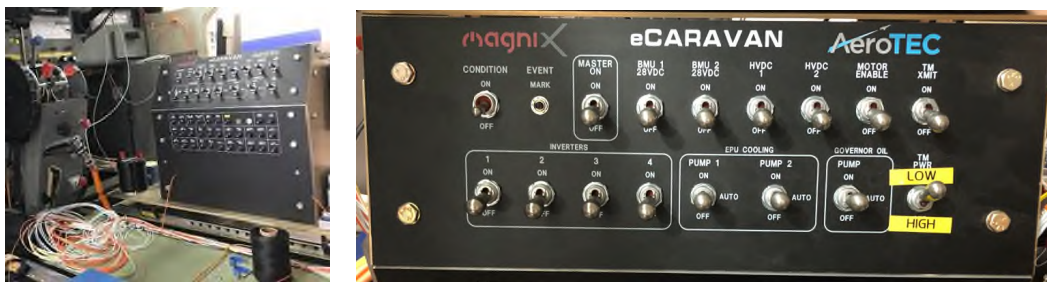
DAS Rack & Mounting Plate on Co-pilot's Seat Rails

DAS Rack Switches

Figure 11 – DAS Rack & Switches

The following is a list of DAS switch functionality shown in Fig. 11 listed from left to right, top to bottom:

- **CONDITION (ON/OFF):** Used to start recording of telemetry (TM) data
- **EVENT:** Used to place a mark in the TM data stream for post test data analysis

- **MASTER ON (ON/OFF):** Power switch to the DAS system. Required to be ON to power up all the systems
- **BMU 1 28 V (ON/OFF):** Power switch for the #1 BMU that managed half of the ESS batteries

- **BMU 2 28 V (ON/OFF):** Power switch for the #2 BMU that managed the other half of the ESS batteries
- **HVDC 1 (ON/OFF):** Power switch for the #1 High Voltage system that provided high voltage DC power to half of the engine inverters

- **HVDC 2 (ON/OFF):** Power switch for the #2 High Voltage system that provided high voltage DC power to the other half of the engine inverters
- **MOTOR ENABLE (ON/OFF):** Engine Run/Cutoff switch used to start and shut down the engine

- **TM XMIT (ON/OFF):** Telemetry power switch
- **INVERTERS 1/2/3/4 (ON/OFF):** The power switches for the four respective magniDrive(s)
- **EPU COOLING PUMP 1 & 2 (ON/AUTO/OFF):**
The power switches for the two engine and magniDrive cooling circuits

- **GOVERNOR OIL PUMP (ON/AUTO/OFF):**
The power switch for the governor oil pump. The system provided pressurized oil to the governor for propeller pitch control

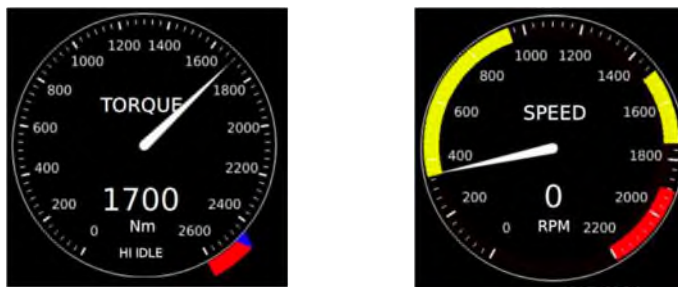
The primary Engine Instrument Torque and Speed gauges, located in the upper left and right sections of the display, mimicked the analogue legacy gauges of the PT-6 engine that the magni500 had replaced. The Torque dial gauge displayed commanded and engine output (feedback) torque calculated by the inverter. The Speed gauge displayed engine RPM. Like the legacy displays, amber sections were "keep out"/transient zones, i.e. no dwelling, and the red sections were "keep out"/limit zones. See Figure 13.

Figure 13 – Primary Instruments

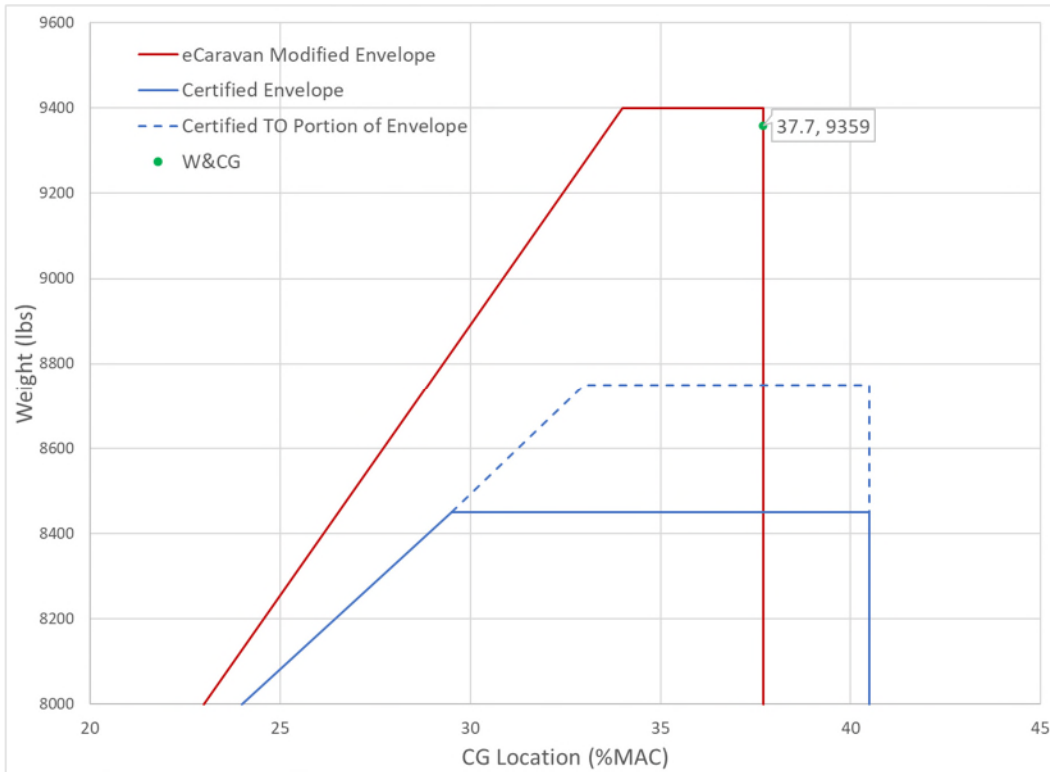
Changes made to the aircraft through the addition of the magniX EPU and ESS system had a significant effect on the aircrafts Basic Empty Weight (BEW), overall Gross Weight (GW), and aircraft Center of Gravity (CG). Following modifications, the aircraft BEW increased to 9,050 lbs. This resulted in a GW of 9,360 lbs on first flight. A modified W&B envelope was developed based on structural, performance, and S&C analysis. An operational CG range was established to ensure the modified forward CG limit reflected the elevator authority range, while ensuring the aft CG limit could be maintained following a catastrophic failure of the crankshaft that resulted in a propeller separation. To accomplish this, 70 lbs of ballast was added near the pilot station to bring the CG to 37.7% Mean Aerodynamic Chord (MAC). See Figure 17:

Figure 17 – eCaravan Modified W&B/CG Envelope compared to the Unmodified Caravan

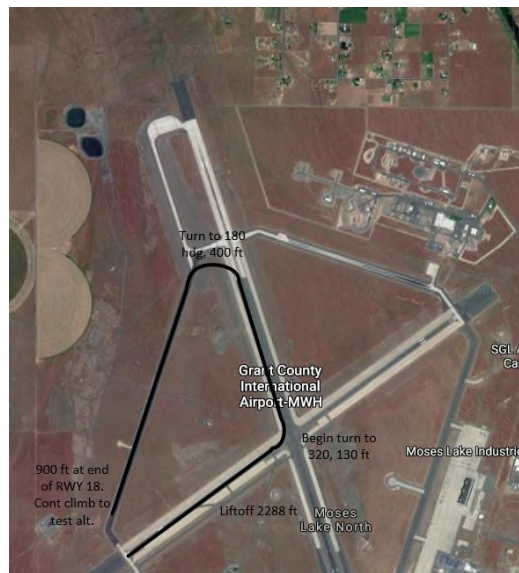
A flight path and vertical profile was chosen to ensure that throughout all phases of flight, the aircraft could glide to a safe landing on a prepared surface following an unplanned loss of thrust. Analysis showed that the glide ratio remained unchanged from the baseline aircraft. Several surveys of the airport surfaces and obstructions were conducted. Fields and structures adjacent to the airport grounds were also assessed as potential off airport emergency ditching sites. All surveys and data were used to settle on the first flight profile. The takeoff would be made from runway 14. Climb data suggested a turn could be made upon reaching the crossing of runway 32. Climb data showed the aircraft should be at 130 ft AGL at this point. Should an engine failure occur during the turn a landing could be made straight ahead on the remaining surface of runway 14 or on the roughly prepared surface of runway 32 following completion of the turn. The next critical point was 400 ft AGL. At this point a turn was planned to parallel runway 18. By the end of runway 18, the aircraft would be at 900 ft AGL. Throughout all phases of the initial climb, performance data showed a landing could be made on one of the prepared surfaces. See Figure 20.

Figure 20 – Initial Climb Out Profile

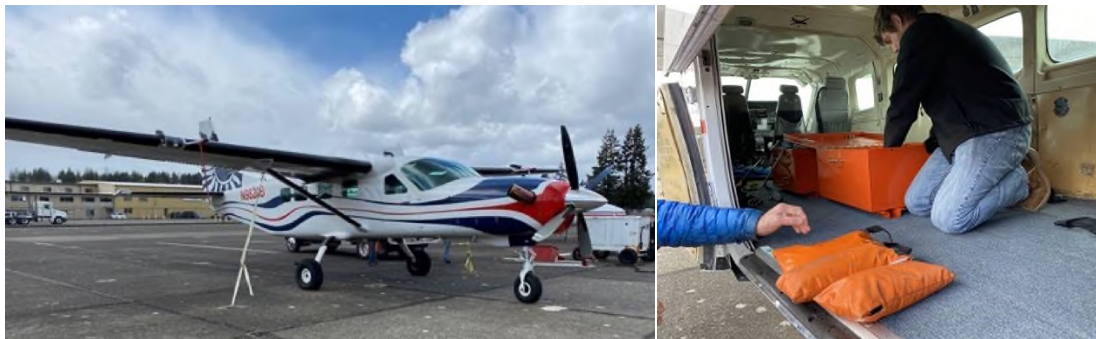
April 27, 2020, the test team completed a training flight on a rental Caravan in preparation for the eCaravan first flight. The objective was to understand the handling characteristics of a Caravan configured similarly to the eCaravan in the landing pattern. The two primary conditions we focused on were short field takeoffs/maximum angle of climbs and power off/simulated feathered propeller landing. In order to simulate the MGTOW planned for the eCaravan, the aircraft was ballasted with two boxes filled with 1,600 lbs of sand bags, which brought the MGTOW up to 9,000 lbs (Figure 21 shows the rental aircraft and ballast system). To simulate the reduced thrust performance of 605 shaft horsepower, the team planned to manually limit takeoff/go around thrust to 1,800 lbs of torque. The flaps 20 short field takeoff procedures were used for all takeoffs up to 420 ft AGL, followed by accelerations to 95 KIAS flaps 10 and 105 KIAS flaps up.

Figure 21 – Rental Caravan and Ballast System

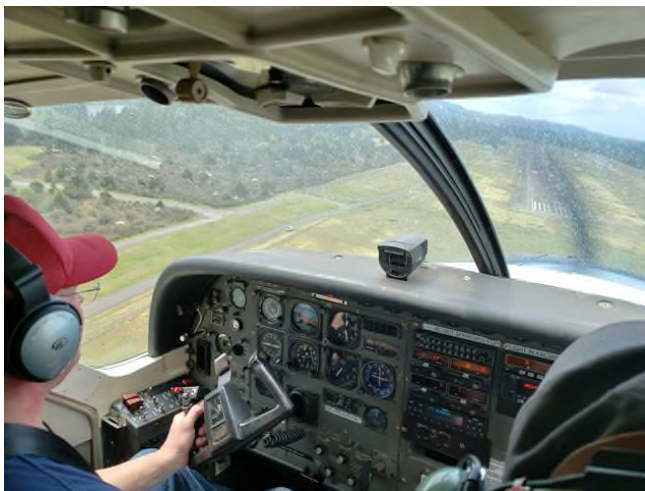
Simulated power out/feathered landings were executed from both left hand and right-hand patterns. Consistent patterns and landings within the first 1,000 ft of the touchdown zone were achieved by flying a continuous 15-25 degree AOB turn, flaps 10, and slow deceleration from 95 KIAS to 90 KIAS until short final. Flap selections of 20 to 30 degrees were delayed until achieving the runway was assured. A full cross control sideslip was consistently applied to achieve precise touchdown points (Figure 22).

Figure 22 – Simulated Power Out/Feathered Landing in the Practice Caravan
