First Flight of the eCaravan – magniX and AeroTEC’s All-Electric Cessna 208B Technology Demonstrator

Abstract

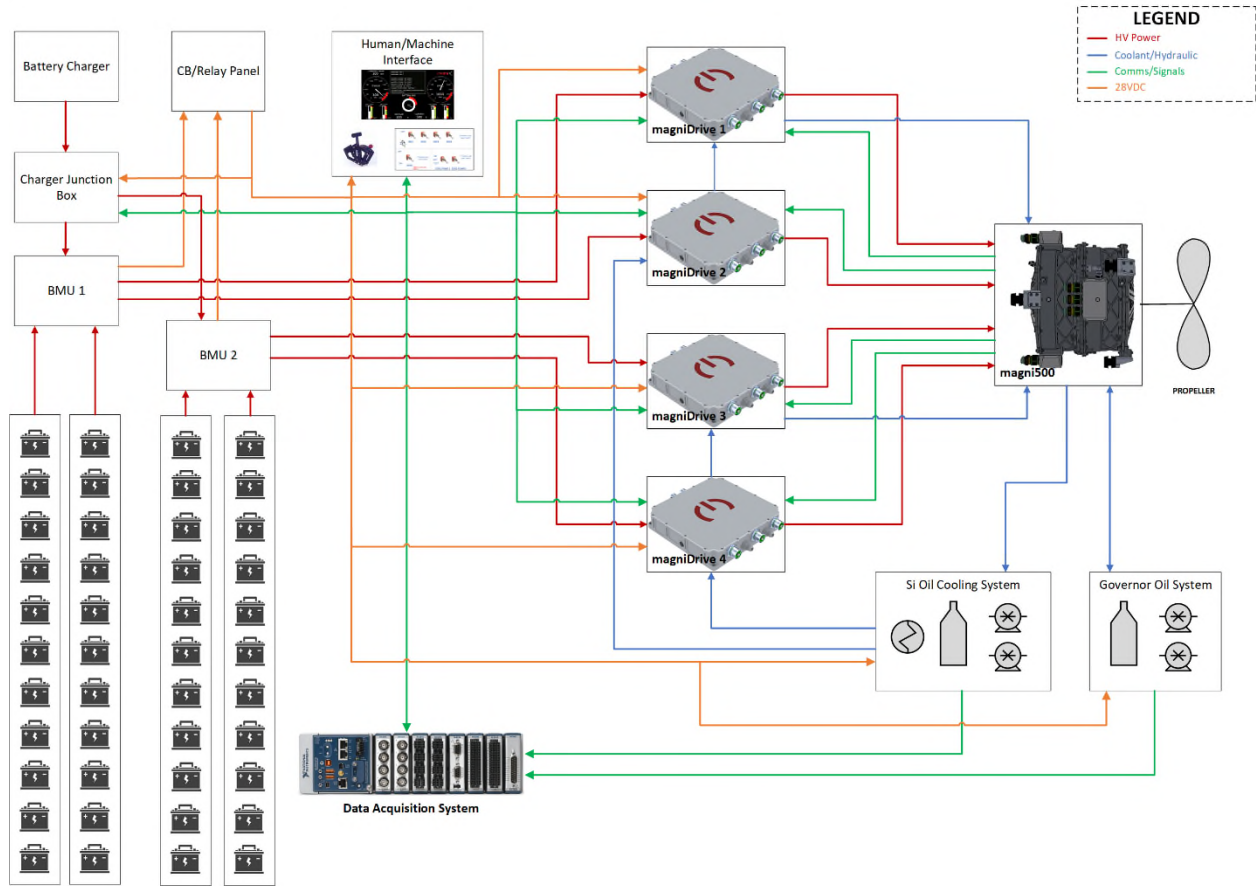
Fig. 2 Electric Power Train System Architecture

The magniX magni500 electric engine was a propulsion system that converts electric energy into mechanical power for aerospace propulsion applications. The system combined a single electric engine (magni500) with four independent engine controllers (magniDrives), cooling system, governor oil feed system and Human Machine Interface (HMI) into a single system. The motor, magniDrives and support equipment together are referred to as an electric engine or Electric Propulsion Unit (EPU) and was developed as a direct replacement for mid-size traditional Pratt & Whitney PT6 turbo prop engines for electric retrofits of existing aircraft, or clean sheet designs.

The motor and magniDrives were liquid cooled, with two independent cooling systems forming a split system that remain functional in the event of the loss of a single cooling system. The architecture of the EPU (Fig. 2) is comprised of four independent segments, each controlled by a separate magniDrive, with the remaining segments remaining fully functional in the event of the loss of a single or multiple inverters. This redundancy and graceful degradation of system performance in the event of the failure of a single component without loss of the entire EPU was a key design principle employed by magniX in the development of the system, with the intent to design a system with greater levels of safety and reliability than traditional propulsion systems for single engine applications.

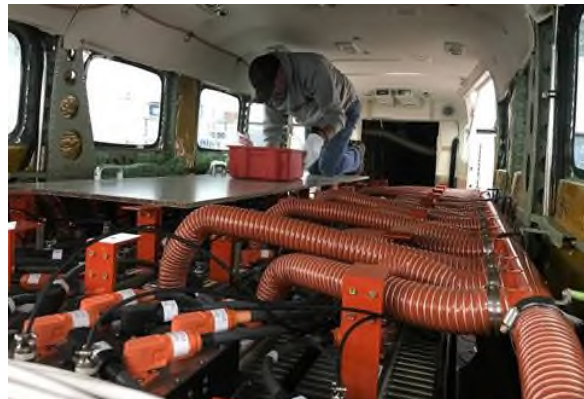
Fig. 10 Battery Cluster Assembly, Ducting, & False Floor

The design of the battery system was intended to provide the highest level of safety level through its internal module design, independent of the integration into the aircraft. The majority of the integration efforts were focused on the mechanical fixtures required to ensure sufficient structural capacity due to the large mass. Optimization of the module configuration was performed to provide enough spacing between modules to aid with passive cooling. Ducting was installed to provide an escape path for gases generated if a thermal runaway event happened. Thermal and system monitoring were some of the principal drivers in the design with each battery cell housed in individual casings that provided a passive means to contain thermal heating and to isolate individual cells from cascading thermal runaway events. Any off-gassing through ports on the top of each cell could be collected and ported overboard through a fan and ducting system designed specifically to handle such occurrences. A false floor was placed over the batteries and ducting to provide an additional egress path for the test pilot and safety for personnel as shown in Fig. 10:

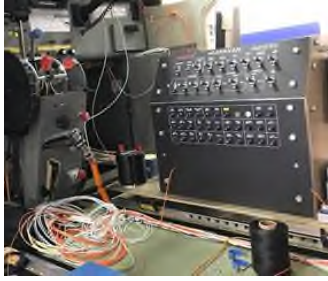
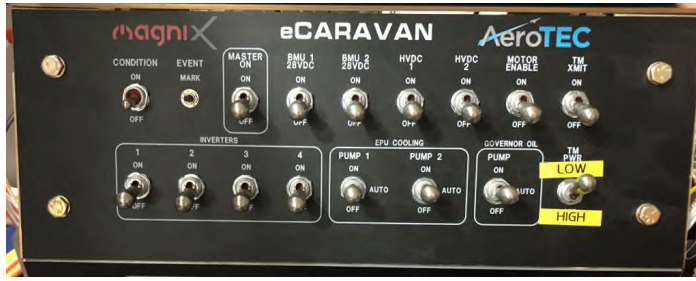
Fig. 11 DAS Rack & Switches

The EPU and ESS were controlled through a custom designed control panel separate to the standard aircraft equipment. It was designed with clearly labeled switch and Circuit Breaker (CB) panels. The rack also housed the data acquisition and telemetry equipment and together was referred to as the Data Acquisition System (DAS). The rack was mounted on a plate attached to the co-pilot's seat rails (Fig. 11). Its placement ensured all switches and CB's were within the pilot's Field of Regard and could be accessed and manipulated from a static seated position using a normal reach.

The following is a list of DAS switch functionality shown in Fig. 11 listed from left to right, top to bottom:

- **CONDITION (ON/OFF):** Used to start recording of telemetry (TM) data
- **EVENT:** Used to place a mark in the TM data stream for post test data analysis

- **MASTER ON (ON/OFF):** Power switch to the DAS system. Required to be ON to power up all the systems
- **BMU 1 28 V (ON/OFF):** Power switch for the #1 BMU that managed half of the ESS batteries

- **BMU 2 28 V (ON/OFF):** Power switch for the #2 BMU that managed the other half of the ESS batteries
- **HVDC 1 (ON/OFF):** Power switch for the #1 High Voltage system that provided high voltage DC power to half of the engine inverters

- **HVDC 2 (ON/OFF):** Power switch for the #2 High Voltage system that provided high voltage DC power to the other half of the engine inverters
- **MOTOR ENABLE (ON/OFF):** Engine Run/Cutoff switch used to start and shut down the engine

- **TM XMIT (ON/OFF):** Telemetry power switch
- **INVERTERS 1/2/3/4 (ON/OFF):** The power switches for the four respective magniDrive(s)
- **EPU COOLING PUMP 1 & 2 (ON/AUTO/OFF):**
The power switches for the two engine and magniDrive cooling circuits

- **GOVERNOR OIL PUMP (ON/AUTO/OFF):**
The power switch for the governor oil pump. The system provided pressurized oil to the governor for propeller pitch control

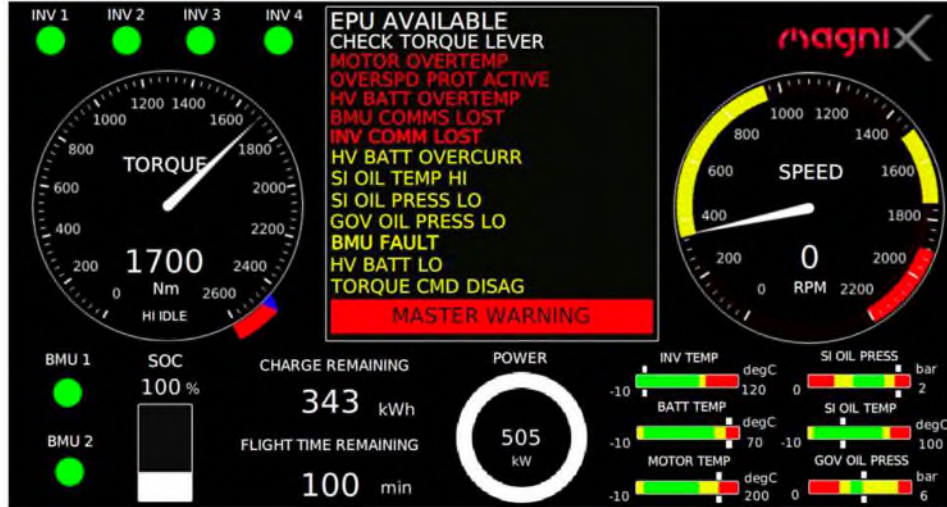
Fig. 12 Overview of the Flight Deck Engine Display

Engine monitoring was provided through a single magniX provided custom display (Fig. 12) mounted on the main instrument panel adjacent to the Comm/Nav radio head stack. It was powered through the aircraft's 28VDC main engine power bus. Information from each of the four magniDrives and the ESS was routed to the display on the EPU CAN bus. In line with convention, any loss of communications between inverters and components would result in a red X appearing over the associated information.

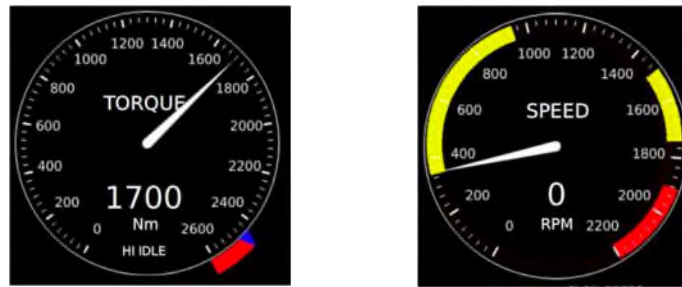
Fig. 13 Primary Instruments

The primary Engine Instrument Torque and Speed gauges, located in the upper left and right sections of the display, mimicked the analogue legacy gauges of the PT-6 engine that the magni500 had replaced. The Torque dial gauge displayed commanded and engine output (feedback) torque calculated by the inverter. The Speed gauge displayed engine RPM. Like the legacy displays, amber sections were "keep out"/transient zones, i.e. no dwelling, and the red sections were "keep out"/limit zones. See Fig. 13.

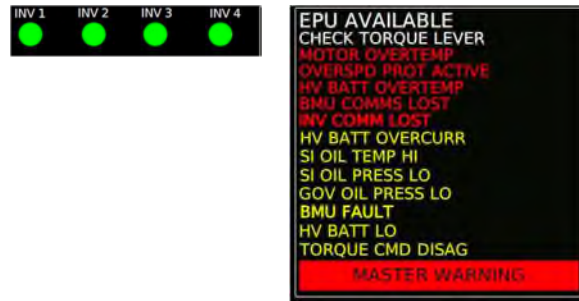
Fig. 14 Crew Alerting System

The Crew Alerting System, shown in Fig. 14, consisted of a conventional CAS messaging area and magniDrive State Indicator lights. These state indicator lights were used to alert the crew in the even any of a number of internal fault conditions were present in the inverter. If no fault state existed, the light would remain green.

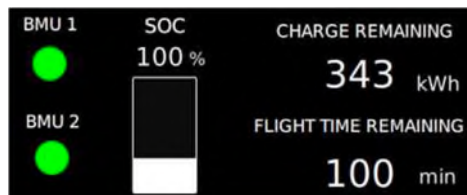
Fig. 15 ESS Status Region

The BMU status was communicated via status lights on the display. They were red if the input contractors for either string of the two associated battery strings were OPEN. The status lights were green when both contactors for

the associated battery strings were CLOSED. A yellow status light indicated both contactors were CLOSED; however, Battery Control Computer in that BMU encountered a fault.

The State of Charge (SOC) displayed the current total ESS state of charge. The charge state was displayed by both a tape and a digital readout in a percent of current charge.

The CHARGE REMAINING was a digital readout of the amount of energy remaining in the batteries, expressed in kWh. The value was calculated based on SOC information provided by the ESS BMU's SOC of their connected strings.

FLIGHT TIME REMAINING, expressed in minutes, was a digital readout of the number of minutes of flight time remaining based on real time current power settings of the engine and the SOC.

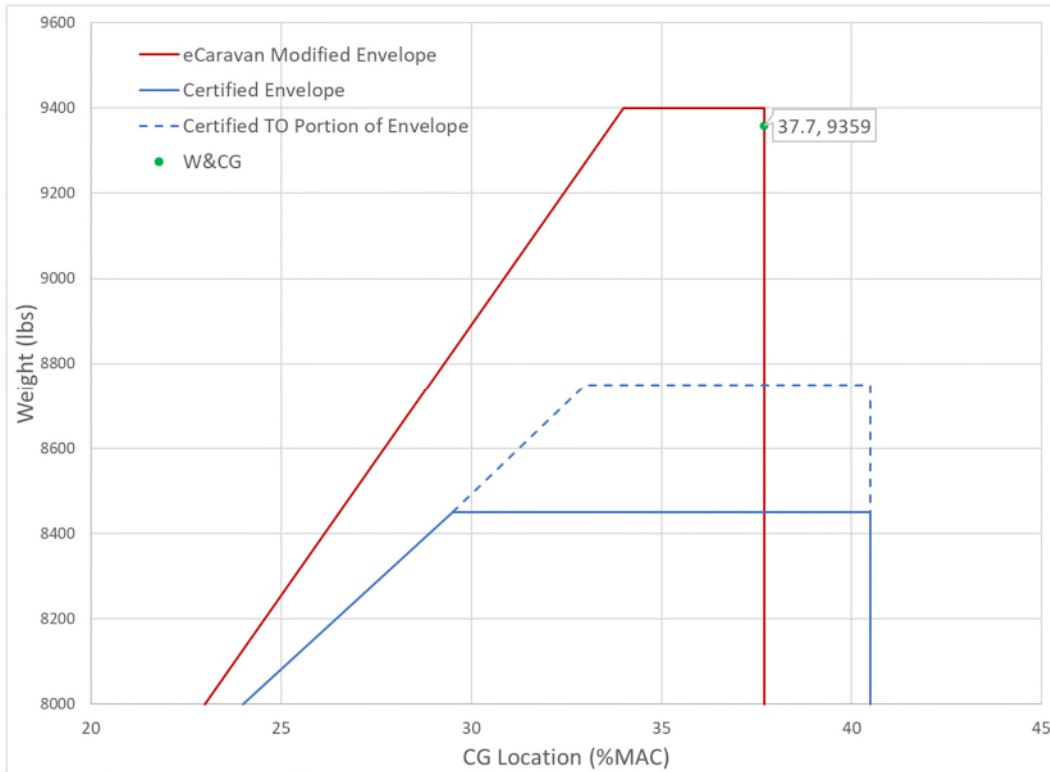
Fig. 17 eCaravan Modified W&B/CG Envelope compared to the Unmodified Caravan

Changes made to the aircraft through the addition of the magniX EPU and ESS system had a significant effect on the aircrafts Basic Empty Weight (BEW), overall Gross Weight (GW), and aircraft Center of Gravity (CG). Following modifications, the aircraft BEW increased to 9,050 lbs. This resulted in a GW of 9,360 lbs on first flight. A modified W&B envelope was developed based on structural, performance, and S&C analysis. An operational CG range was established to ensure the modified forward CG limit reflected the elevator authority range, while ensuring the aft CG limit could be maintained following a catastrophic failure of the crankshaft that resulted in a propeller separation. To accomplish this, 70 lbs of ballast was added near the pilot station to bring the CG to 37.7% Mean Aerodynamic Chord (MAC). See Fig. 17:

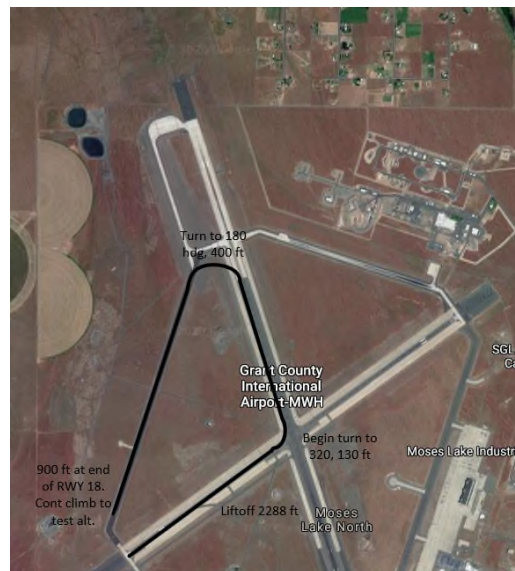
Fig. 20 Initial Climb Out Profile

A flight path and vertical profile was chosen to ensure that throughout all phases of flight, the aircraft could glide to a safe landing on a prepared surface following an unplanned loss of thrust. Analysis showed that the glide ratio remained unchanged from the baseline aircraft. Several surveys of the airport surfaces and obstructions were conducted. Fields and structures adjacent to the airport grounds were also assessed as potential off airport emergency ditching sites. All surveys and data were used to settle on the first flight profile. The takeoff would be made from runway 14. Climb data suggested a turn could be made upon reaching the crossing of runway 32. Climb data showed the aircraft should be at 130 ft AGL at this point. Should an engine failure occur during the turn a landing could be made straight ahead on the remaining surface of runway 14 or on the roughly prepared surface of runway 32 following completion of the turn. The next critical point was 400 ft AGL. At this point a turn was planned to parallel runway 18. By the end of runway 18, the aircraft would be at 900 ft AGL. Throughout all phases of the initial climb, performance data showed a landing could be made on one of the prepared surfaces. See Fig. .

Sufficient altitude was planned in the cruise and landing phases of flight to ensure a power off glide to runway 14 could be made at any time.

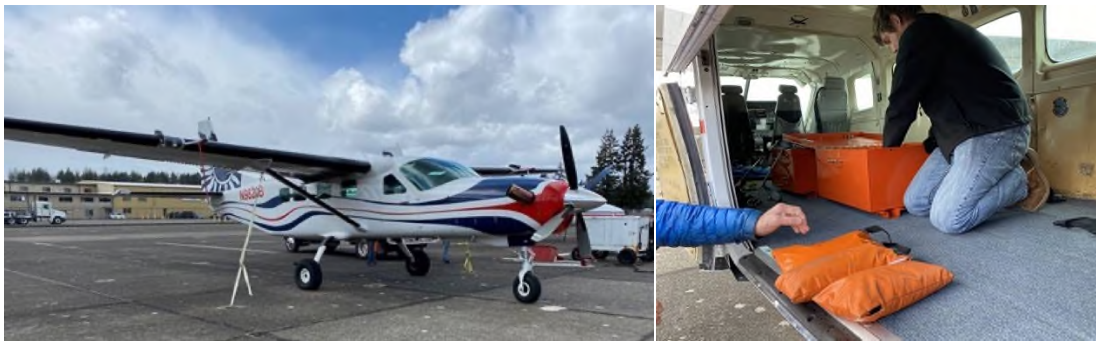
Fig. 21 Rental Caravan and Ballast System

April 27, 2020, the test team completed a training flight on a rental Caravan in preparation for the eCaravan first flight. The objective was to understand the handling characteristics of a Caravan configured similarly to the eCaravan in the landing pattern. The two primary conditions we focused on were short field takeoffs/maximum angle of climbs and power off/simulated feathered propeller landing. In order to simulate the MGTOW planned for the eCaravan, the aircraft was ballasted with two boxes filled with 1,600 lbs of sand bags, which brought the MGTOW up to 9,000 lbs (Fig. 21 shows the rental aircraft and ballast system). To simulate the reduced thrust performance of 605 shaft

horsepower, the team planned to manually limit takeoff/go around thrust to 1,800 lbs of torque. The flaps 20 short field takeoff procedures were used for all takeoffs up to 420 ft AGL, followed by accelerations to 95 KIAS flaps 10 and 105 KIAS flaps up.

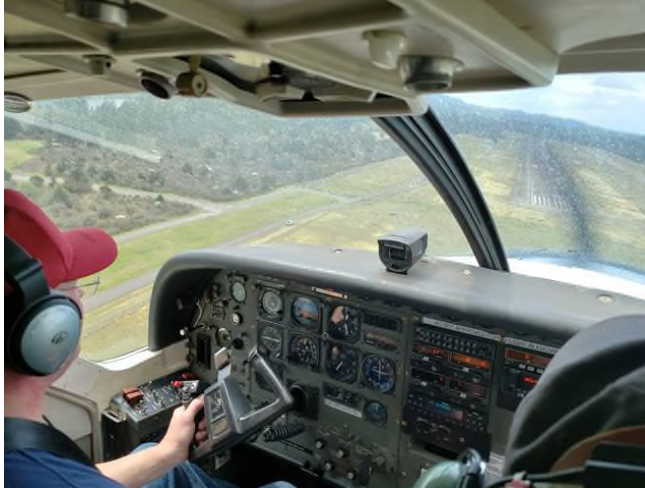
Fig. 22 Simulated Power Out/Feathered Landing in the Practice Caravan

Simulated power out/feathered landings were executed from both left hand and right-hand patterns. Consistent patterns and landings within the first 1,000 ft of the touchdown zone were achieved by flying a continuous 15-25 degree AOB turn, flaps 10, and slow deceleration from 95 KIAS to 90 KIAS until short final. Flap selections of 20 to 30 degrees were delayed until achieving the runway was assured. A full cross control sideslip was consistently applied to achieve precise touchdown points (Fig. 22).

After a 2 hour flight and 18 successful landings, the Test Pilot was able to consistently place the aircraft in the touchdown zone and safely bring the aircraft to a stop with no power and a simulated feathered propeller.
