FIRST FLIGHT OF THE ECARAVAN

magnix and AeroTEC's All-Electric
Cessna 208B Technology Demonstrator

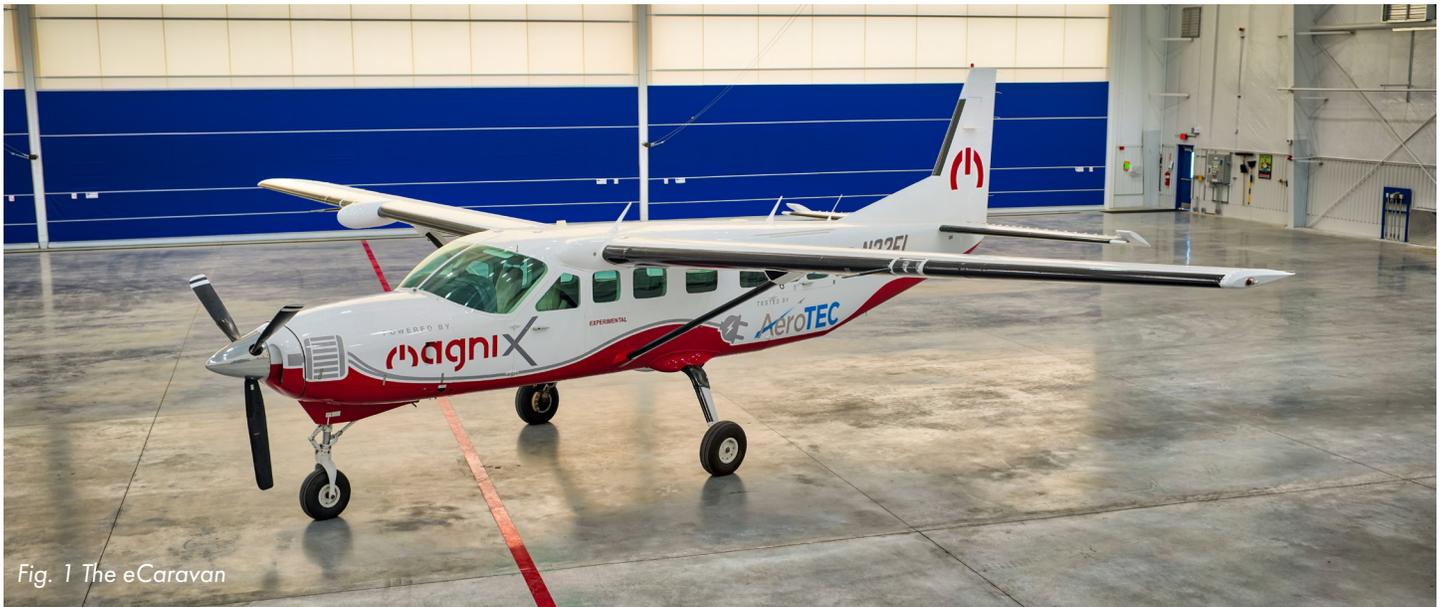
Fig. 1 The eCaravan

The eCaravan project was initiated by magniX in early 2019 for the purpose of demonstrating the viability of electric powered flight through the retrofit of an aircraft of a size used in commercial applications, and to further develop the technology through integration and flight test that would form the basis of future development and eventual type certification. The eCaravan, Fig. 1, was based on a Cessna 208B Grand Caravan, a popular 9-seat single engine PT6 turbine powered aircraft used extensively around the world in commercial applications ranging from recreation and bush flying to serving remote communities. The core technology of the electric power train was the magniX "magni500" electric propulsion system and a 258 kwh lithium battery based energy storage system.

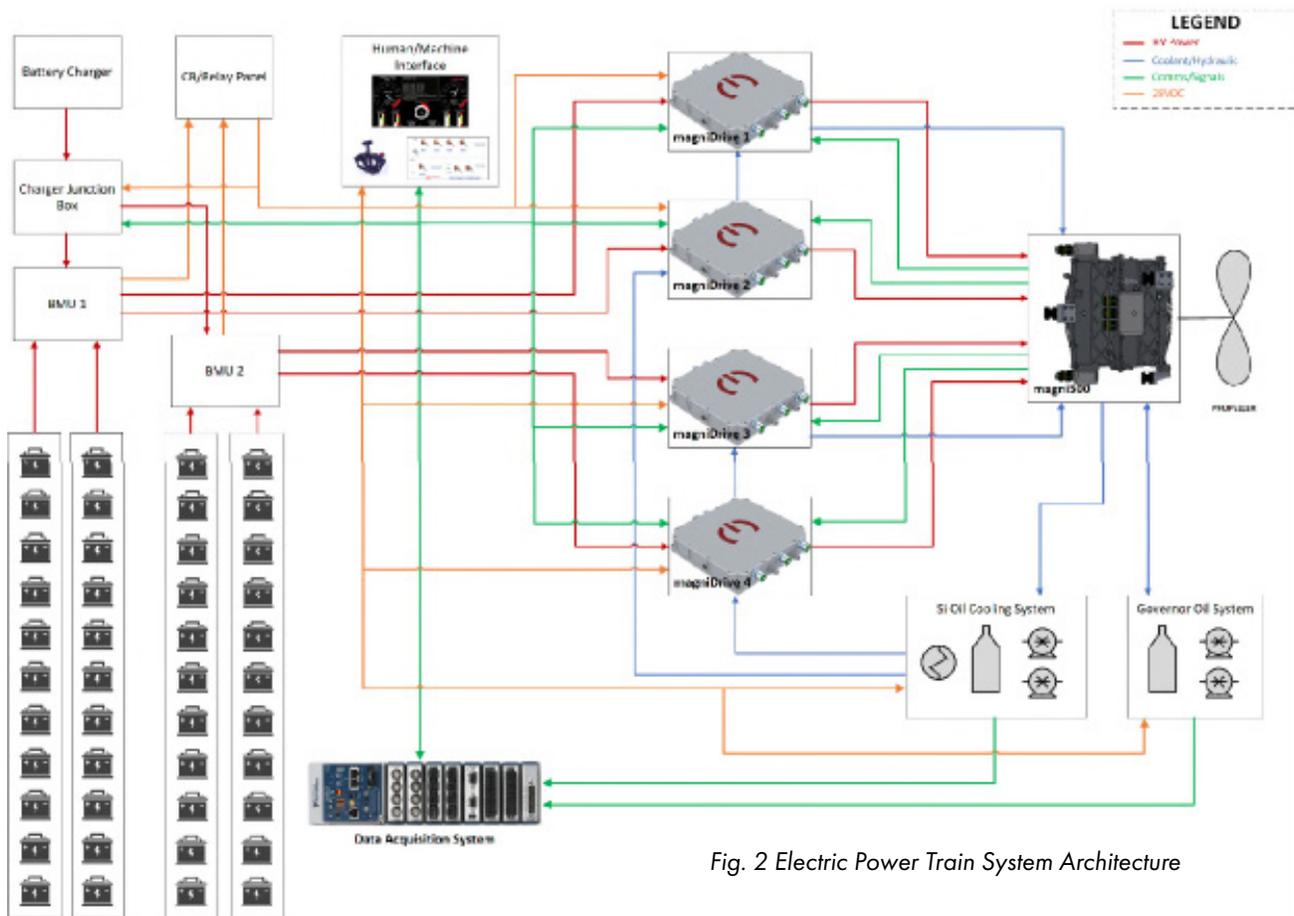
Fig. 2 Electric Power Train System Architecture

The magniX magni500 electric engine was a propulsion system that converts electric energy into mechanical power for aerospace propulsion applications. The system combined a single electric engine (magni500) with four independent engine controllers (magniDrives), cooling system, governor oil feed system and Human Machine

Interface (HMI) into a single system. The motor, magniDrives and support equipment together are referred to as an electric engine or Electric Propulsion Unit (EPU) and was developed as a direct replacement for mid-size traditional Pratt & Whitney PT6 turbo prop engines for electric retrofits of existing aircraft, or clean sheet designs.

The motor and magniDrives were liquid cooled, with two independent cooling systems forming a split system that remain functional in the event of the loss of a single cooling system. The architecture of the EPU (Fig. 2) is comprised of four independent segments, each controlled by a separate magniDrive, with the remaining segments remaining fully functional in the event of the loss of a single or multiple inverters. This redundancy and graceful degradation of system performance in the event of the failure of a single component without loss of the entire EPU was a key design principle employed by magniX in the development of the system, with the intent to design a system with greater levels of safety and reliability than traditional propulsion systems for single engine applications.

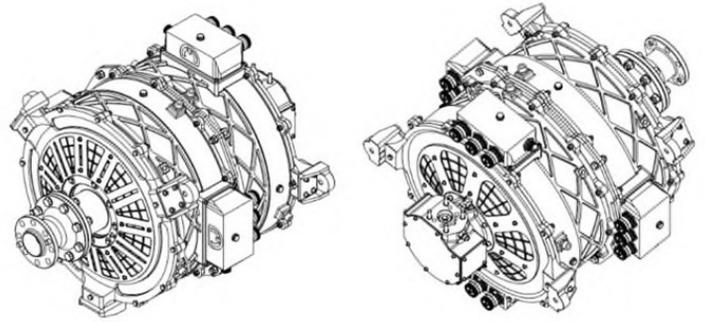
Fig. 3 magni500 Electric Engine

The magni500 was a liquid cooled direct drive permanent magnet synchronous machine with four independent three phase groups, with each group controlled by a separate three phase variable frequency inverter and controller (magniDrive).

The engine is capable of continuously delivering up to 560kw (750 shp) of shaft power at 1900RPM to drive a conventional constant speed propeller. Speed control was achieved via a traditional hydromechanical propeller governor mounted to an accessory gearbox on the rear, with high pressure oil fed through the shaft to the propeller hub.

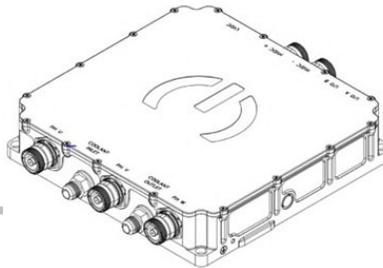
Fig. 4 magniX magniDrive

The magni500 based EPU was controlled by four independent controllers (magniDrives). Each magniDrive is a single 3 phase variable frequency drive, converting DC power to AC current regulated by the torque command from the aircrafts power lever.

In addition to the core function of torque control, each magniDrive also acted as a health and performance monitor, with an independent condition motoring unit, which ensured the accurate control of the motor, provided error detection and communication to the HMI display, and could act to shut down its segment in the event of a detected failure. This dual command and monitoring functionality was a core element of system safety built into the magniX EPU.

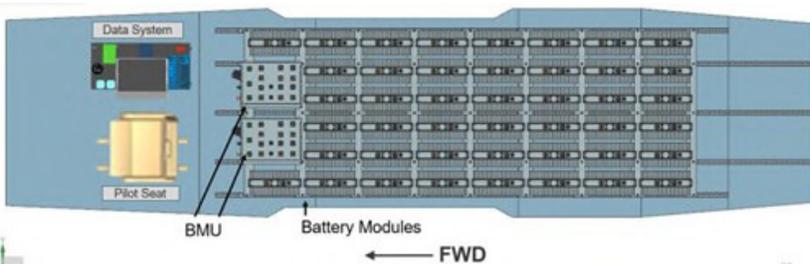
Fig. 5 ESS Cabin Layout

The Energy Storage System (ESS) replaced the conventional fuel system and supporting subsystems on the aircraft with electrical energy storage, in this case batteries. The ESS in the eCaravan consisted of two independent battery systems, each with a dedicated Battery Management Units (BMU) and two strings of 11 battery modules for a total of four battery strings in the aircraft. The batteries and BMUs were located along the inside of the fuselage in what is normally the passenger cabin. Due to the experimental nature of the program, the battery system was designed for safety and practical integration rather than optimized for weight or volume, and as such filled most of the available cabin space and useful payload, shown in Fig. 5. The selection of the battery cell used in the project was also focused on the maturity and experience from the supplier with that specific cell model.

The ESS was selected and contracted in order to deliver sufficient capacity to support demonstration flights with a design that would guard against cascading thermal runaway events in flight and be able to operate under all expected flight campaign operational environment without the necessity of liquid thermal management system. The result was a robust lithium-based battery system designed to meet the specification shown in Table 1.

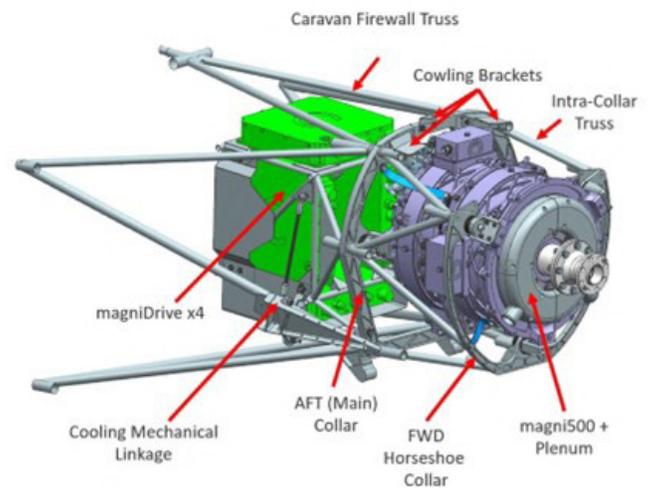
Fig. 6 magniX EPU Integration

Design modifications to the Caravan motor mount were developed to interface directly into the existing Caravan engine mount support truss for the PT6 engine being replaced. In addition to the electric engine, the new mount also provided mounting for the drives, cooling system, governor oil system, sensors and pumps, as shown in Fig. 6. No modifications to the Caravan firewall truss were needed. A stress analysis was performed on the new mounting bracket system and all components, including the original Caravan firewall truss, showing positive margins for all loading cases. The engine mount analysis followed a 14 CFR part 23 approach noting that electric engines have some unique loading conditions that are not issues on traditional gas turbines owing to the ability to spin up very quickly. The magniDrives limit start up torque in an effort to prevent high stress levels in the motor mount and blades during start up.

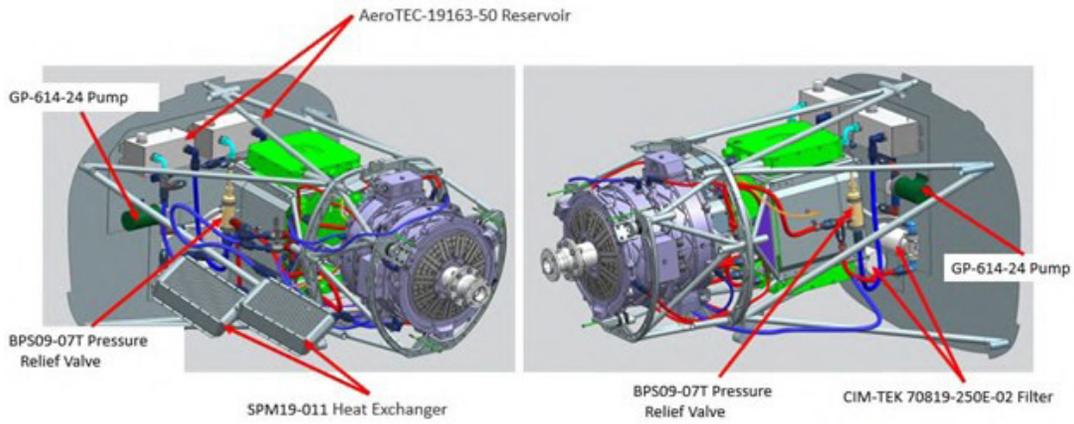
Fig. 7 Cooling System Installation Layout

The EPU cooling system consisted of two independent silicon oil-based systems each with its own pump, filter and heat exchanger all installed forward of the firewall as shown in Fig. 7. Each system provided cooling for one half of the EPU and two magniDrives. The cooling pumps were powered from the aircraft 28V LVDC system and were controlled with two toggle switches (labeled Pump 1 and Pump 2 with Auto, On, and Off positions) located on the EPU/ESS test panel in the flight deck.

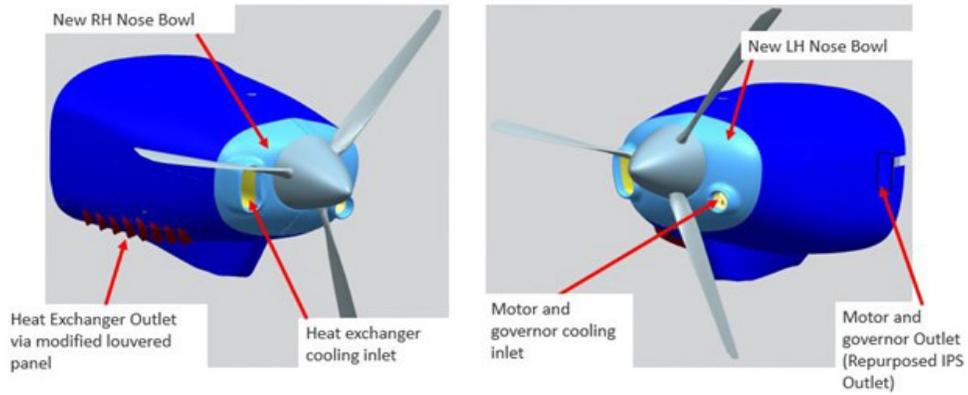
Fig. 8 Custom Nose Bowl and Mounts

The aircraft side of the cooling system was designed to provide for sufficient cooling of the EPU at takeoff power with an outside temperature of 35°C. The system consisted of two heat exchanges, one for each independent cooling oil loop, and required ducting integrated into the exhaust ports for the traditional PT6 (Fig. 9). A new nose bowl was manufactured to provide for a cooling air scoop in the nose, shown in Fig. 8.

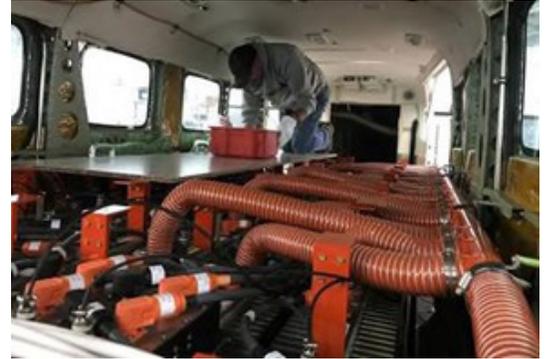
Fig. 10 Battery Cluster Assembly, Ducting, & False Floor

The design of the battery system was intended to provide the highest level of safety level through its internal module design, independent of the integration into the aircraft. The majority of the integration efforts were focused on the mechanical fixtures required to ensure sufficient structural capacity due to the large mass. Optimization of the module configuration was performed to provide enough spacing between modules to aid with passive cooling. Ducting was installed to provide an escape path for gases generated if a thermal runaway event happened. Thermal and system monitoring were some of the principal drivers in the design with each battery cell housed in individual casings that provided a passive means to contain thermal heating and to isolate individual cells from cascading thermal runaway events. Any off-gassing through ports on the top of each cell could be collected and ported overboard through a fan and ducting system designed specifically to handle such occurrences. A false floor was placed over the batteries and ducting to provide an additional egress path for the test pilot and safety for personnel as shown in Fig. 10:

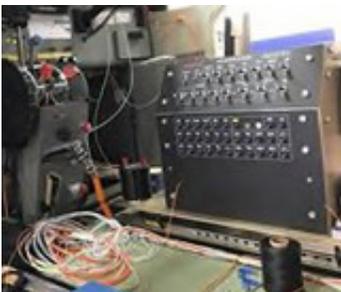
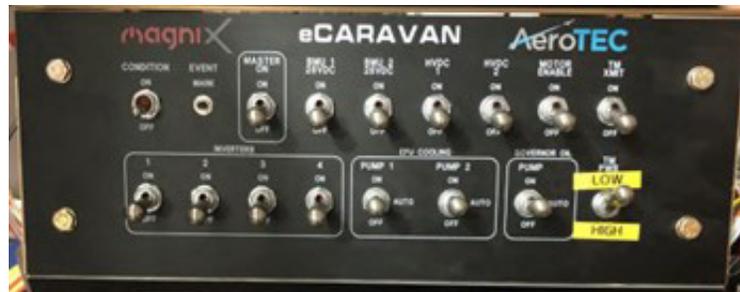
Fig. 11 DAS Rack & Switches

The EPU and ESS were controlled through a custom designed control panel separate to the standard aircraft equipment. It was designed with clearly labeled switch and Circuit Breaker (CB) panels. The rack also housed the data acquisition and telemetry equipment and together was referred to as the Data Acquisition System (DAS). The rack was mounted on a plate attached to the co-pilot's seat rails (Fig. 11). Its placement ensured all switches and CB's were within the pilot's Field of Regard and could be accessed and manipulated from a static seated position using a normal reach.

The following is a list of DAS switch functionality shown in Fig. 11 listed from left to right, top to bottom:

CONDITION (ON/OFF)	Used to start recording of telemetry (TM) data
EVENT	Used to place a mark in the TM data stream for post test data analysis
MASTER ON (ON/OFF)	Power switch to the DAS system. Required to be ON to power up all the systems
BMU 1 28 V (ON/OFF)	Power switch for the #1 BMU that managed half of the ESS batteries
BMU 2 28 V (ON/OFF)	Power switch for the #2 BMU that managed the other half of the ESS batteries
HVDC 1 (ON/OFF)	Power switch for the #1 High Voltage system that provided high voltage DC power to half of the engine inverters
HVDC 2 (ON/OFF)	Power switch for the #2 High Voltage system that provided high voltage DC power to the other half of the engine inverters
MOTOR ENABLE (ON/OFF)	Engine Run/Cutoff switch used to start and shut down the engine
TM XMIT (ON/OFF)	Telemetry power switch
INVERTERS 1/2/3/4 (ON/OFF)	The power switches for the four respective magniDrive(s)
EPU COOLING PUMP 1 & 2 (ON/AUTO/OFF)	The power switches for the two engine and magniDrive cooling circuits

GOVERNOR OIL PUMP (ON/AUTO/OFF)	The power switch for the governor oil pump. The system provided pressurized oil to the governor for propeller pitch control

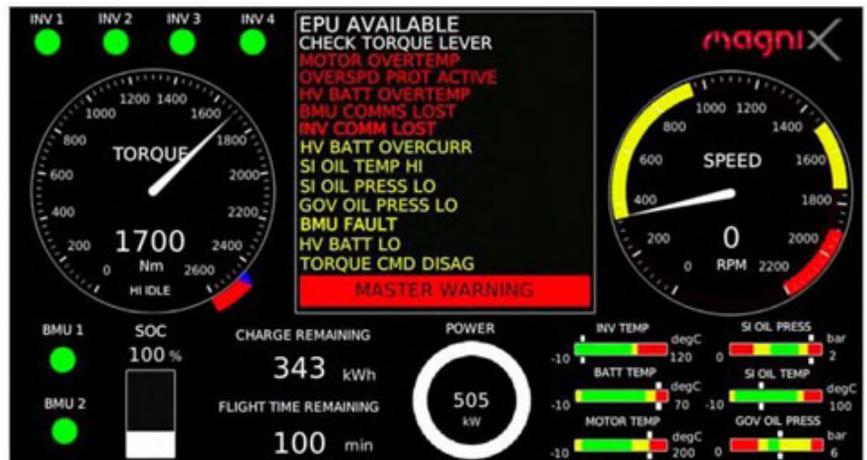
Fig. 12 Overview of the Flight Deck Engine Display

Engine monitoring was provided through a single magniX provided custom display (Fig. 12) mounted on the main instrument panel adjacent to the Comm/Nav radio head stack. It was powered through the aircraft's 28VDC main engine power bus. Information from each of the four magniDrives and the ESS was routed to the display on the EPU CAN bus. In line with convention, any loss of communications between inverters and components would result in a red X appearing over the associated information.

The primary Engine Instrument Torque and Speed gauges, located in the upper left and right sections of the display, mimicked the analogue legacy gauges of the PT-6 engine that the magni500 had replaced. The Torque dial gauge displayed commanded and engine output (feedback) torque calculated by the inverter. The Speed gauge displayed engine RPM. Like the legacy displays, amber sections were "keep out"/transient zones, i.e. no dwelling, and the red sections were "keep out"/limit zones. See Fig. 13.

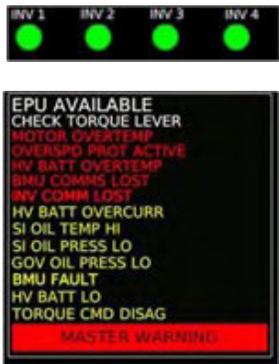
Fig. 14 Crew Alerting System

The Crew Alerting System, shown in Fig. 14, consisted of a conventional CAS messaging area and magniDrive State Indicator lights. These state indicator lights were used to alert the crew in the event any of a number of internal fault conditions were present in the inverter. If no fault state existed, the light would remain green.

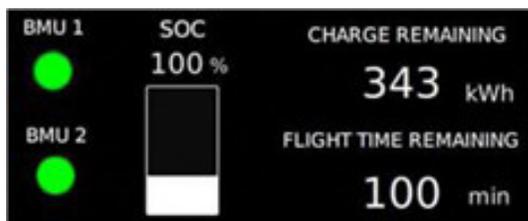
Fig. 15 ESS Status Region

The BMU status was communicated via status lights on the display. They were red if the input contactors for either string of the two associated battery strings were OPEN. The status lights were green when both contactors for

the associated battery strings were CLOSED. A yellow status light indicated both contactors were CLOSED; however, Battery Control Computer in that BMU encountered a fault.

The State of Charge (SOC) displayed the current total ESS state of charge. The charge state was displayed by both a tape and a digital readout in a percent of current charge.

The CHARGE REMAINING was a digital readout of the amount of energy remaining in the batteries, expressed in kWh. The value was calculated based on SOC information provided by the ESS BMU's SOC of their connected strings.

FLIGHT TIME REMAINING, expressed in minutes, was a digital readout of the number of minutes of flight time remaining based on real time current power settings of the engine and the SOC.

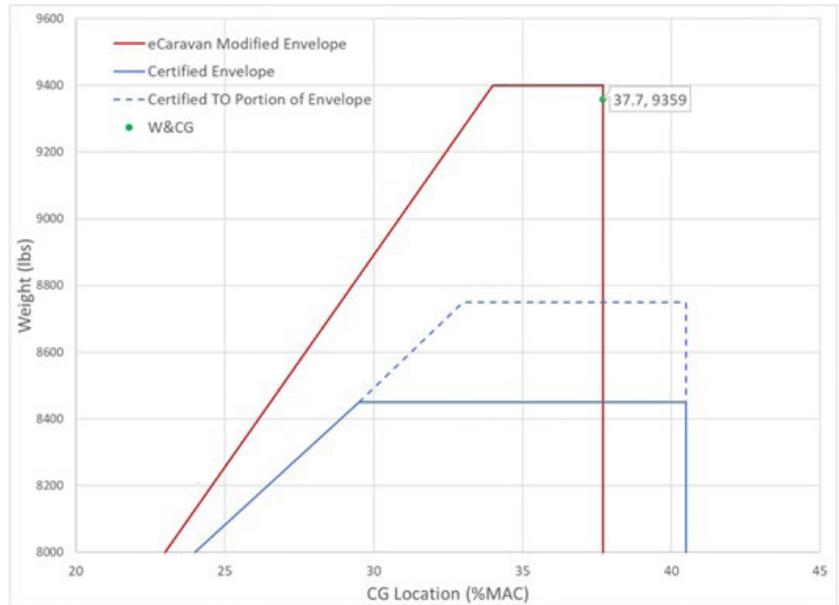
Fig. 17 eCaravan Modified W&B/CG Envelope compared to the Unmodified Caravan

Changes made to the aircraft through the addition of the magniX EPU and ESS system had a significant effect on the aircraft's Basic Empty Weight (BEW), overall Gross Weight (GW), and aircraft Center of Gravity (CG). Following modifications, the aircraft BEW increased to 9,050 lbs. This resulted in a GW of 9,360 lbs on first flight. A modified W&B envelope was developed based on structural, performance, and S&C analysis. An operational CG range was established to ensure the modified forward CG limit reflected the elevator authority range, while ensuring the aft CG limit could be maintained following a catastrophic failure of the crankshaft that resulted in a propeller separation. To accomplish this, 70 lbs of ballast was added near the pilot station to bring the CG to 37.7% Mean Aerodynamic Chord (MAC). See Fig. 17:

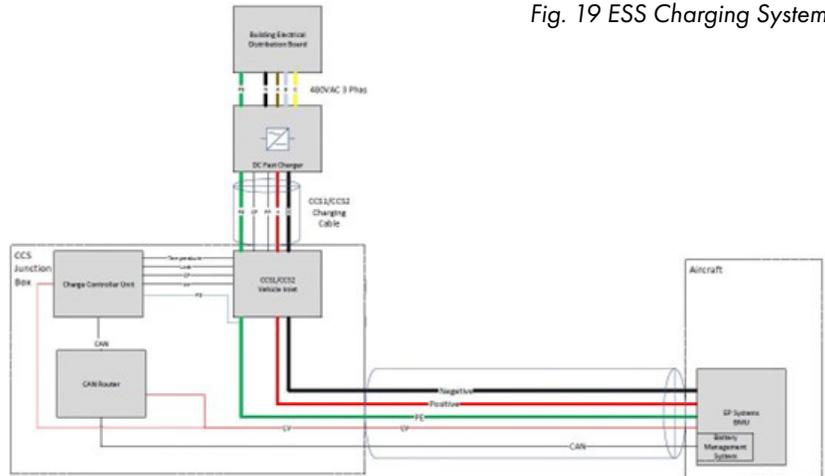
Fig. 19 ESS Charging System

The redundant architecture of the ESS also allowed the team to have each pack charge independently. In that case, having 2 independent 75kW DC fast charger systems would allow the team to re-charge the aircraft at a reasonable rate. The figure below shows the schematic for each of the charging systems.

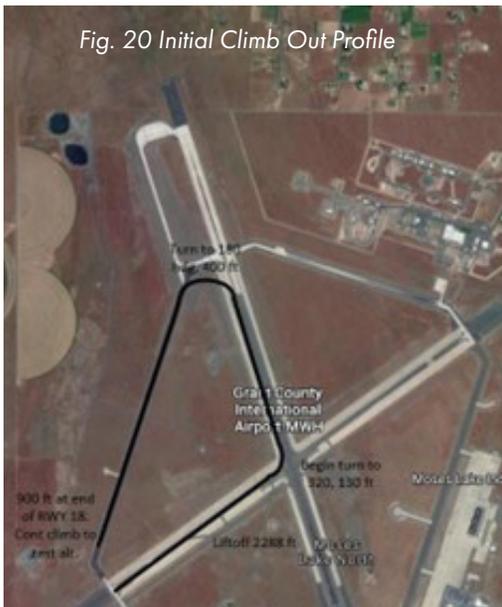
A flight path and vertical profile was chosen to ensure that throughout all phases of flight, the aircraft could glide to a safe landing on a prepared surface following an unplanned loss of thrust. Analysis showed that the glide ratio remained unchanged from the baseline aircraft. Several surveys of the airport surfaces and obstructions were

conducted. Fields and structures adjacent to the airport grounds were also assessed as potential off airport emergency ditching sites. All surveys and data were used to settle on the first flight profile. The takeoff would be made from runway 14. Climb data suggested a turn could be made upon reaching the crossing of runway 32. Climb data showed the aircraft should be at 130 ft AGL at this point. Should an engine failure occur during the turn a landing could be made straight ahead on the remaining surface of runway 14 or on the roughly prepared surface of runway 32 following completion of the turn. The next critical point was 400 ft AGL. At this point a turn was planned to parallel runway 18. By the end of runway 18, the aircraft would be at 900 ft AGL. Throughout all phases of the initial climb, performance data showed a landing could be made on one of the prepared surfaces. See Fig. 20.

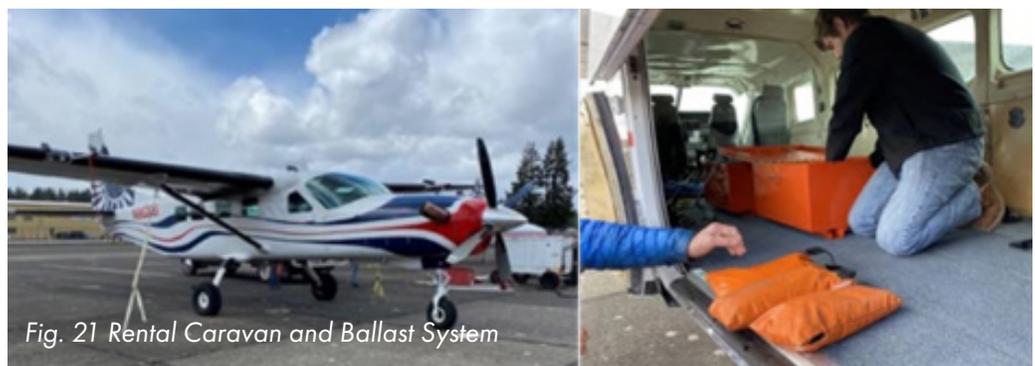
Fig. 21 Rental Caravan and Ballast System

April 27, 2020, the test team completed a training flight on a rental Caravan in preparation for the eCaravan first flight. The objective was to understand the handling characteristics of a Caravan configured similarly to the eCaravan in the landing pattern. The two primary conditions we focused on were short field takeoffs/maximum angle of climbs and power off/simulated feathered propeller landing. In order to simulate the MGTOW planned for the eCaravan, the aircraft was ballasted with two boxes filled with 1,600 lbs of sand bags, which brought the MGTOW up to 9,000 lbs (Fig. 21 shows the rental aircraft and ballast system). To simulate the reduced thrust performance of 605 shaft horsepower, the team planned to manually limit takeoff/go around thrust to 1,800 lbs of torque. The flaps 20 short field takeoff procedures were used for all takeoffs up to 420 ft AGL, followed by accelerations to 95 KIAS flaps 10 and 105 KIAS flaps up.

The aircraft climbing up to 6,000 ft MSL then slowed to a best glide speed of 95 KIAS. The pilot pulled the throttle back to idle and feathered the propeller. The aircraft was flown in low idle for the entire flight. The aircraft settled into an 800 ft/min descent and an altitude loss of approximately

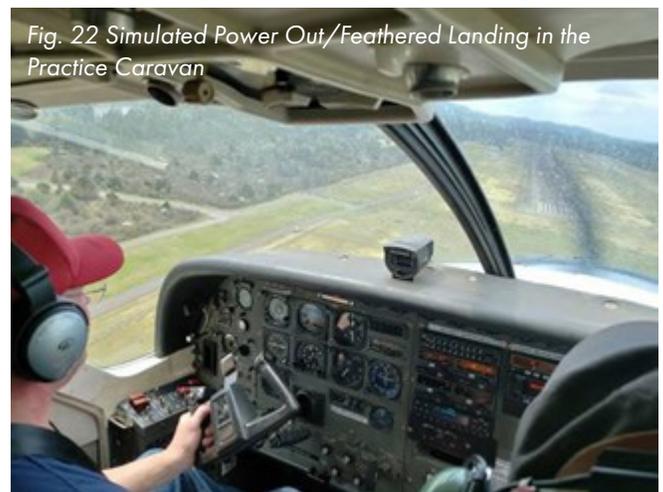
Fig. 22 Simulated Power Out/Feathered Landing in the Practice Caravan

Simulated power out/feathered landings were executed from both left hand and right-hand patterns. Consistent patterns and landings within the first 1,000 ft of the touchdown zone were achieved by flying a continuous 15-25 degree AOB turn, flaps 10, and slow deceleration from 95 KIAS to 90 KIAS until short final. Flap selections of 20 to 30 degrees were delayed until achieving the runway was assured. A full cross control sideslip was consistently applied to achieve precise touchdown points (Fig. 22).

After a 2 hour flight and 18 successful landings, the Test Pilot was able to consistently place the aircraft in the touchdown zone and safely bring the aircraft to a stop with no power and a simulated feathered propeller.
