FIRST FLIGHT OF THE ECARAVAN

magnix and AeroTEC's All-Electric
Cessna 208B Technology Demonstrator

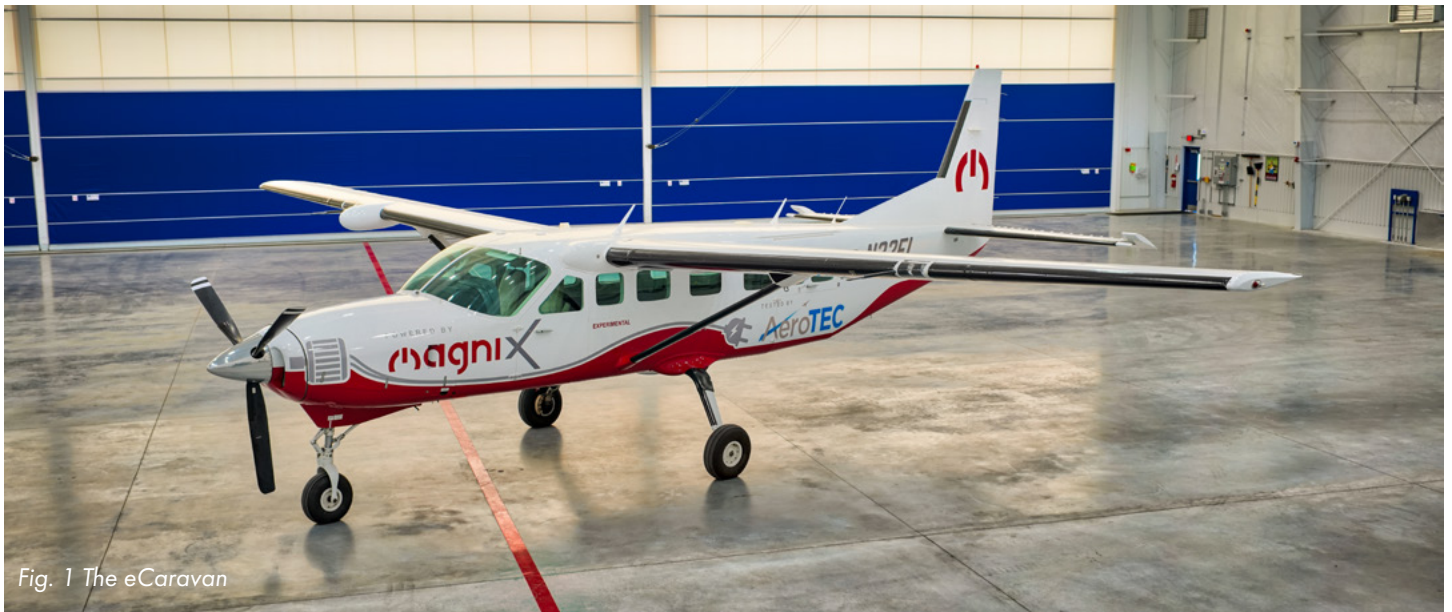
Fig. 1 The eCaravan

The eCaravan project was initiated by magniX in early 2019 for the purpose of demonstrating the viability of electric powered flight through the retrofit of an aircraft of a size used in commercial applications, and to further develop the technology through integration and flight test that would form the basis of future development and eventual type certification. The eCaravan, Fig. 1, was based on a Cessna 208B Grand Caravan, a popular 9-seat single engine PT6 turbine powered aircraft used extensively around the world in commercial applications ranging from recreation and bush flying to serving remote communities. The core technology of the electric power train was the magniX “magni500” electric propulsion system and a 258 kwh lithium battery based energy storage system.

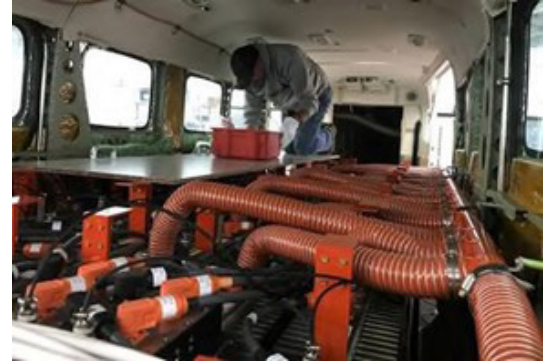
Fig. 10 Battery Cluster Assembly, Ducting, & False Floor

The design of the battery system was intended to provide the highest level of safety level through its internal module design, independent of the integration into the aircraft. The majority of the integration efforts were focused on the mechanical fixtures required to ensure sufficient structural capacity due to the large mass. Optimization of the module configuration was performed to provide enough spacing between modules to aid with passive cooling. Ducting was installed to provide an escape path for gases generated if a thermal runaway event happened. Thermal and system monitoring were some of the principal drivers in the design with each battery cell housed in individual casings that provided a passive means to contain thermal heating and to isolate individual cells from cascading thermal runaway events. Any off-gassing through ports on the top of each cell could be collected and ported overboard through a fan and ducting system designed specifically to handle such occurrences. A false floor was placed over the batteries and ducting to provide an additional egress path for the test pilot and safety for personnel as shown in Fig. 10:

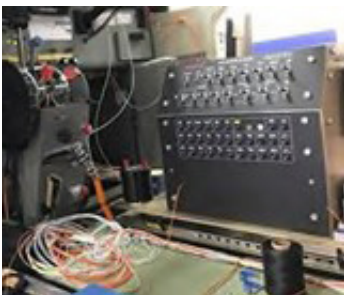
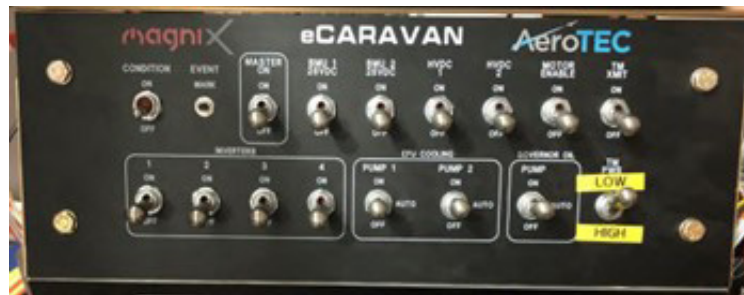
Fig. 11 DAS Rack & Switches

The EPU and ESS were controlled through a custom designed control panel separate to the standard aircraft equipment. It was designed with clearly labeled switch and Circuit Breaker (CB) panels. The rack also housed the data acquisition and telemetry equipment and together was referred to as the Data Acquisition System (DAS). The rack was mounted on a plate attached to the co-pilot's seat rails (Fig. 11). Its placement ensured all switches and CB's were within the pilot's Field of Regard and could be accessed and manipulated from a static seated position using a normal reach.

The following is a list of DAS switch functionality shown in Fig. 11 listed from left to right, top to bottom:

CONDITION (ON/OFF)	Used to start recording of telemetry (TM) data
EVENT	Used to place a mark in the TM data stream for post test data analysis
MASTER ON (ON/OFF)	Power switch to the DAS system. Required to be ON to power up all the systems
BMU 1 28 V (ON/OFF)	Power switch for the #1 BMU that managed half of the ESS batteries
BMU 2 28 V (ON/OFF)	Power switch for the #2 BMU that managed the other half of the ESS batteries
HVDC 1 (ON/OFF)	Power switch for the #1 High Voltage system that provided high voltage DC power to half of the engine inverters
HVDC 2 (ON/OFF)	Power switch for the #2 High Voltage system that provided high voltage DC power to the other half of the engine inverters
MOTOR ENABLE (ON/OFF)	Engine Run/Cutoff switch used to start and shut down the engine
TM XMIT (ON/OFF)	Telemetry power switch
INVERTERS 1/2/3/4 (ON/OFF)	The power switches for the four respective magniDrive(s)
EPU COOLING PUMP 1 & 2 (ON/AUTO/OFF)	The power switches for the two engine and magniDrive cooling circuits

GOVERNOR OIL PUMP (ON/AUTO/OFF)	The power switch for the governor oil pump. The system provided pressurized oil to the governor for propeller pitch control

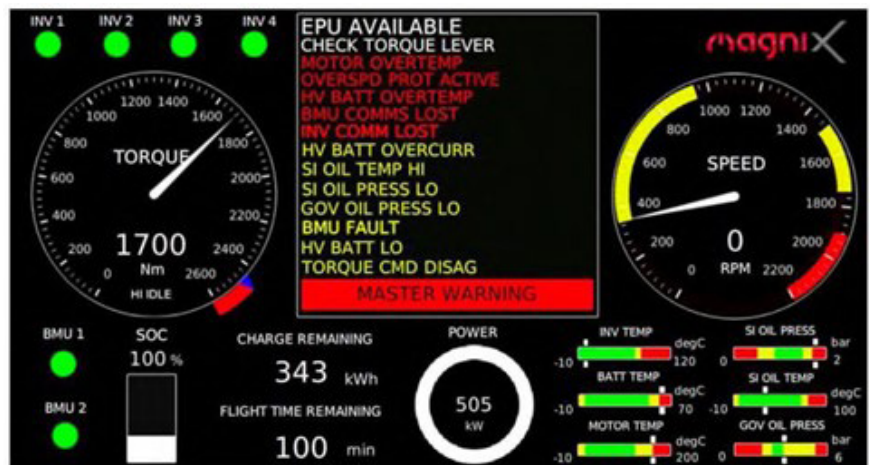
Fig. 12 Overview of the Flight Deck Engine Display

Engine monitoring was provided through a single magniX provided custom display (Fig. 12) mounted on the main instrument panel adjacent to the Comm/Nav radio head stack. It was powered through the aircraft's 28VDC main engine power bus. Information from each of the four magniDrives and the ESS was routed to the display on the EPU CAN bus. In line with convention, any loss of communications between inverters and components would result in a red X appearing over the associated information.

The primary Engine Instrument Torque and Speed gauges, located in the upper left and right sections of the display, mimicked the analogue legacy gauges of the PT-6 engine that the magni500 had replaced. The Torque dial gauge displayed commanded and engine output (feedback) torque calculated by the inverter. The Speed gauge displayed engine RPM. Like the legacy displays, amber sections were "keep out"/transient zones, i.e. no dwelling, and the red sections were "keep out"/limit zones. See Fig. 13.

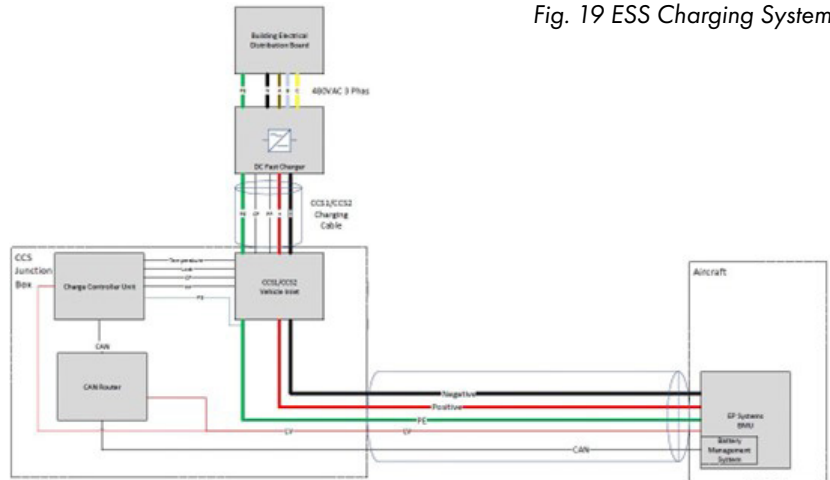
Fig. 19 ESS Charging System

Based on the above a solution of acquiring a commercial charger and building a “junction box” that would allow the team to manage the interface between it and the battery system was the selected solution. The junction box would also include an extension cable.

The redundant architecture of the ESS also allowed the team to have each pack charge independently. In that case, having 2 independent 75kW DC fast charger systems would allow the team to re-charge the aircraft at a reasonable rate. The figure below shows the schematic for each of the charging systems.

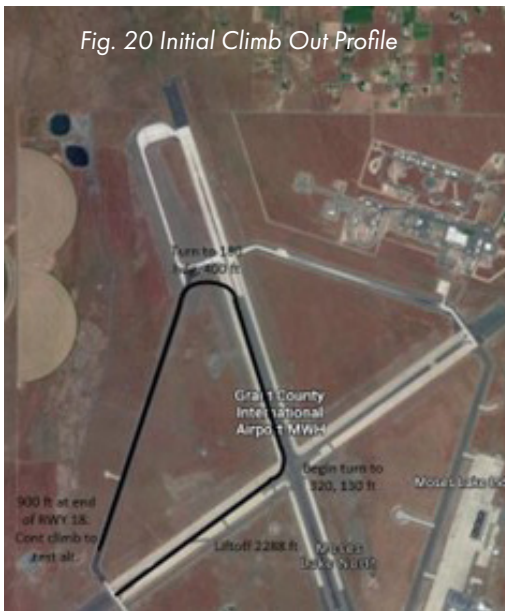
A flight path and vertical profile was chosen to ensure that throughout all phases of flight, the aircraft could glide to a safe landing on a prepared surface following an unplanned loss of thrust. Analysis showed that the glide ratio remained unchanged from the baseline aircraft. Several surveys of the airport surfaces and obstructions were

conducted. Fields and structures adjacent to the airport grounds were also assessed as potential off airport emergency ditching sites. All surveys and data were used to settle on the first flight profile. The takeoff would be made from runway 14. Climb data suggested a turn could be made upon reaching the crossing of runway 32. Climb data showed the aircraft should be at 130 ft AGL at this point. Should an engine failure occur during the turn a landing could be made straight ahead on the remaining surface of runway 14 or on the roughly prepared surface of runway 32 following completion of the turn. The next critical point was 400 ft AGL. At this point a turn was planned to parallel runway 18. By the end of runway 18, the aircraft would be at 900 ft AGL. Throughout all phases of the initial climb, performance data showed a landing could be made on one of the prepared surfaces. See Fig. 20.

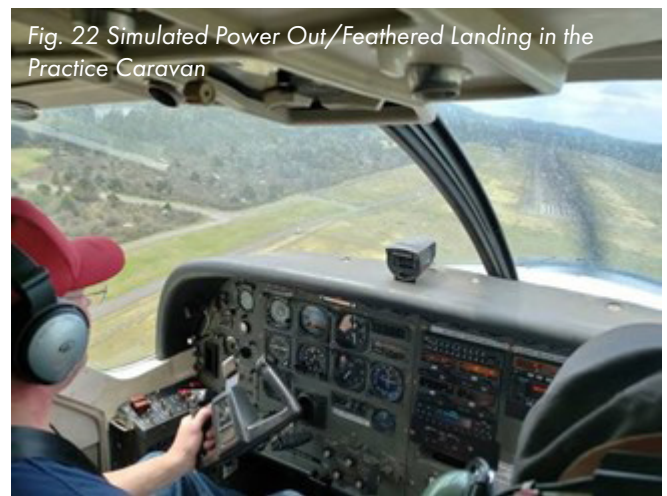
Fig. 22 Simulated Power Out/Feathered Landing in the Practice Caravan

Simulated power out/feathered landings were executed from both left hand and right-hand patterns. Consistent patterns and landings within the first 1,000 ft of the touchdown zone were achieved by flying a continuous 15-25 degree AOB turn, flaps 10, and slow deceleration from 95 KIAS to 90 KIAS until short final. Flap selections of 20 to 30 degrees were delayed until achieving the runway was assured. A full cross control sideslip was consistently applied to achieve precise touchdown points (Fig. 22).

After a 2 hour flight and 18 successful landings, the Test Pilot was able to consistently place the aircraft in the touchdown zone and safely bring the aircraft to a stop with no power and a simulated feathered propeller.
